Manhole Inspection Summary

Manhole # S17CC2006MH

Insp Date: **8/3/06 8:35 AM**

Location Address: **1904 SULGRAVE AVE**

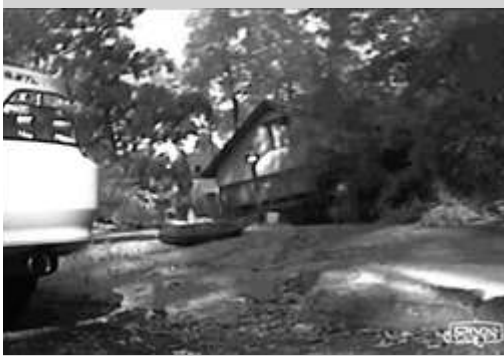
Location View

Comments **The MH is preventing the homeowners from entering their own driveway because it is above grade - damage in the surrounding sidewalk causes their car to hit the MH.**

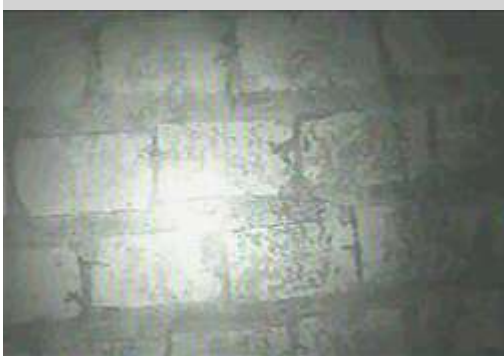
Defect

Infiltration: ☐ None ☐ Joint ☐ Cracks ☒ **Mortar** ☐ Roots ☒ **Wall**

Barrel infiltration.

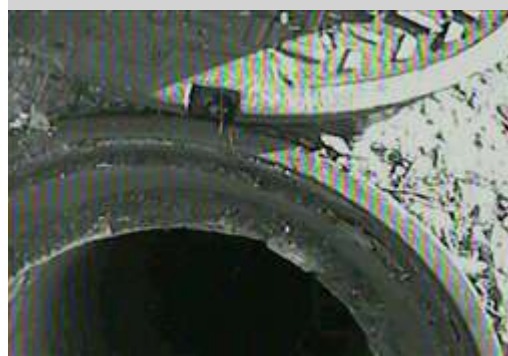
Defect

Offset: **2.5** (in.)

Frame offset.

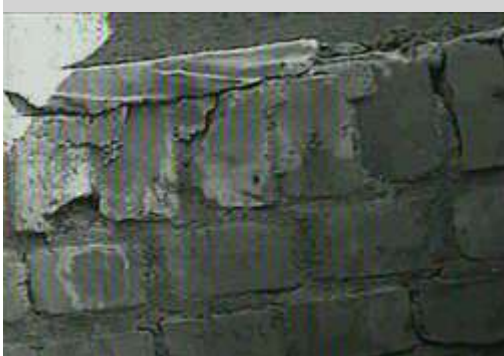
Defect

Condition: ☐ Sound ☐ Cracked ☐ Root Intrusion ☐ Loose Brick ☒ **Deteriorated**

Infiltration: ☐ None ☒ **Joint** ☐ Cracks ☒ **Mortar** ☐ Roots ☐ Wall

Frame leaks. Adjustment deterioration and infiltration.

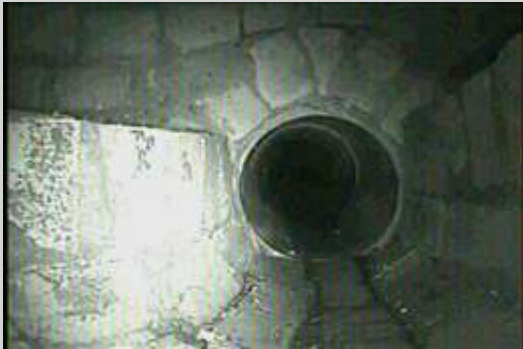
8 in. Circular Gravity Sewer Pipe Out @ 12 O'Clock

Condition: ☐ Sound ☐ Cracked ☐ Root Intrusion ☒ **Deteriorated** ☐ Leaks ☐ Debris

Channel deterioration.

Infiltration: **Evidence** Pipe Seal Cond: **Unknown**

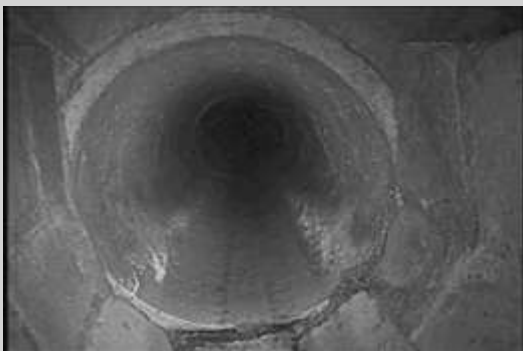
8 in. Circular Gravity Sewer Pipe In @ 6 O'Clock

Deposits: ☐ None ☐ Mud ☐ Sludge ☐ Debris ☒ Grease

Silt Depth: **0** (in.) Deposits Extent: **Light**

Infiltration: **Evidence** Pipe Seal Cond: **Unknown**

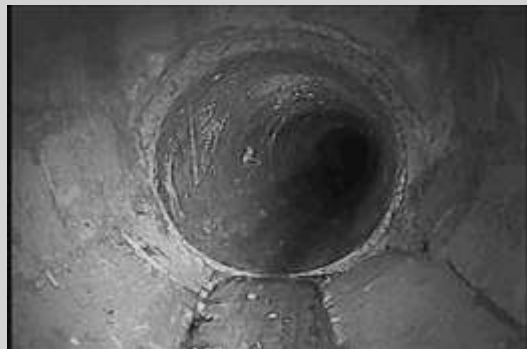
Pipe In @ 9 O'Clock

Infiltration: **Evidence**
